**TECHNICAL REPORTS FOR 1989-1990
APPLIED GEOLOGY PROGRAM**

UTAH GEOLOGICAL AND MINERAL SURVEY
a division of
UTAH DEPARTMENT OF NATURAL RESOURCES
REPORT OF INVESTIGATION 220

TECHNICAL REPORTS FOR 1988-1989 APPLIED GEOLOGY PROGRAM

UTAH GEOLOGICAL AND MINERAL SURVEY
a division of
UTAH DEPARTMENT OF NATURAL RESOURCES
REPORT OF INVESTIGATION 220 May 1990

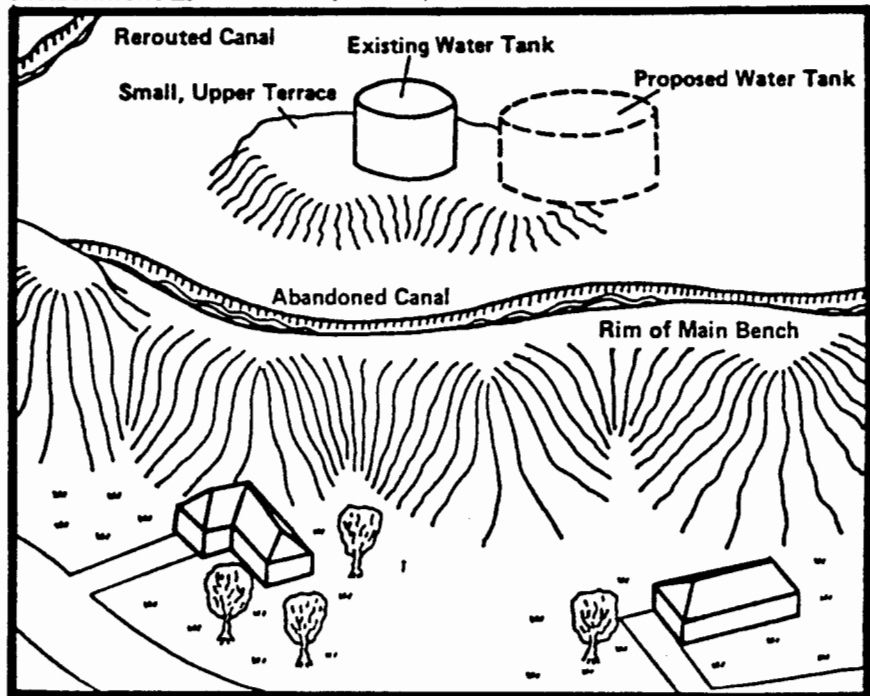
Attachment 2. Job 89-01(PF-2)

The existing water tank is on a small terrace about 10 feet higher than the bench surface (attachment 2), and is approximately 100 feet from the rim of the bench. The proposed water tank will be built partly on this small terrace, approximately 125 feet from the rim of the bench. Much excavation and grading will be required, as the foundation of the proposed water tank will be larger than the remaining undeveloped portion of this terrace surface (attachment 2).

Attachment 2. Sketch of proposed water tank site. Not drawn to scale, view looking towards the southwest.

No geologic hazards are present at the site which would make it unsuitable for construction of the water tank. The re-routing of the Davis-Weber canal away from the rim of the bench near the water tank site will ensure that any future canal leakage will not affect the water tank, the bench slope, or the residential area at

the slope base. Any surface drainage should be routed away from the water tank site. Drainage could easily be routed into the new canal. Although no landslides have been identified on the slopes in the immediate vicinity of the water tank, the possibility of landsliding exists. To minimize the potential for damage from slope failure, the water tank should be set back from the bench slope as far as possible. If the tank is to be placed any closer than is presently planned (approximately 125 feet), a factor of safety analysis of the slope should be considered. In addition, it is recommended that the geotechnical firm performing soil foundation investigations for the water tank be consulted as to the necessity of a slope stability study of the bench to determine safe setback distances.

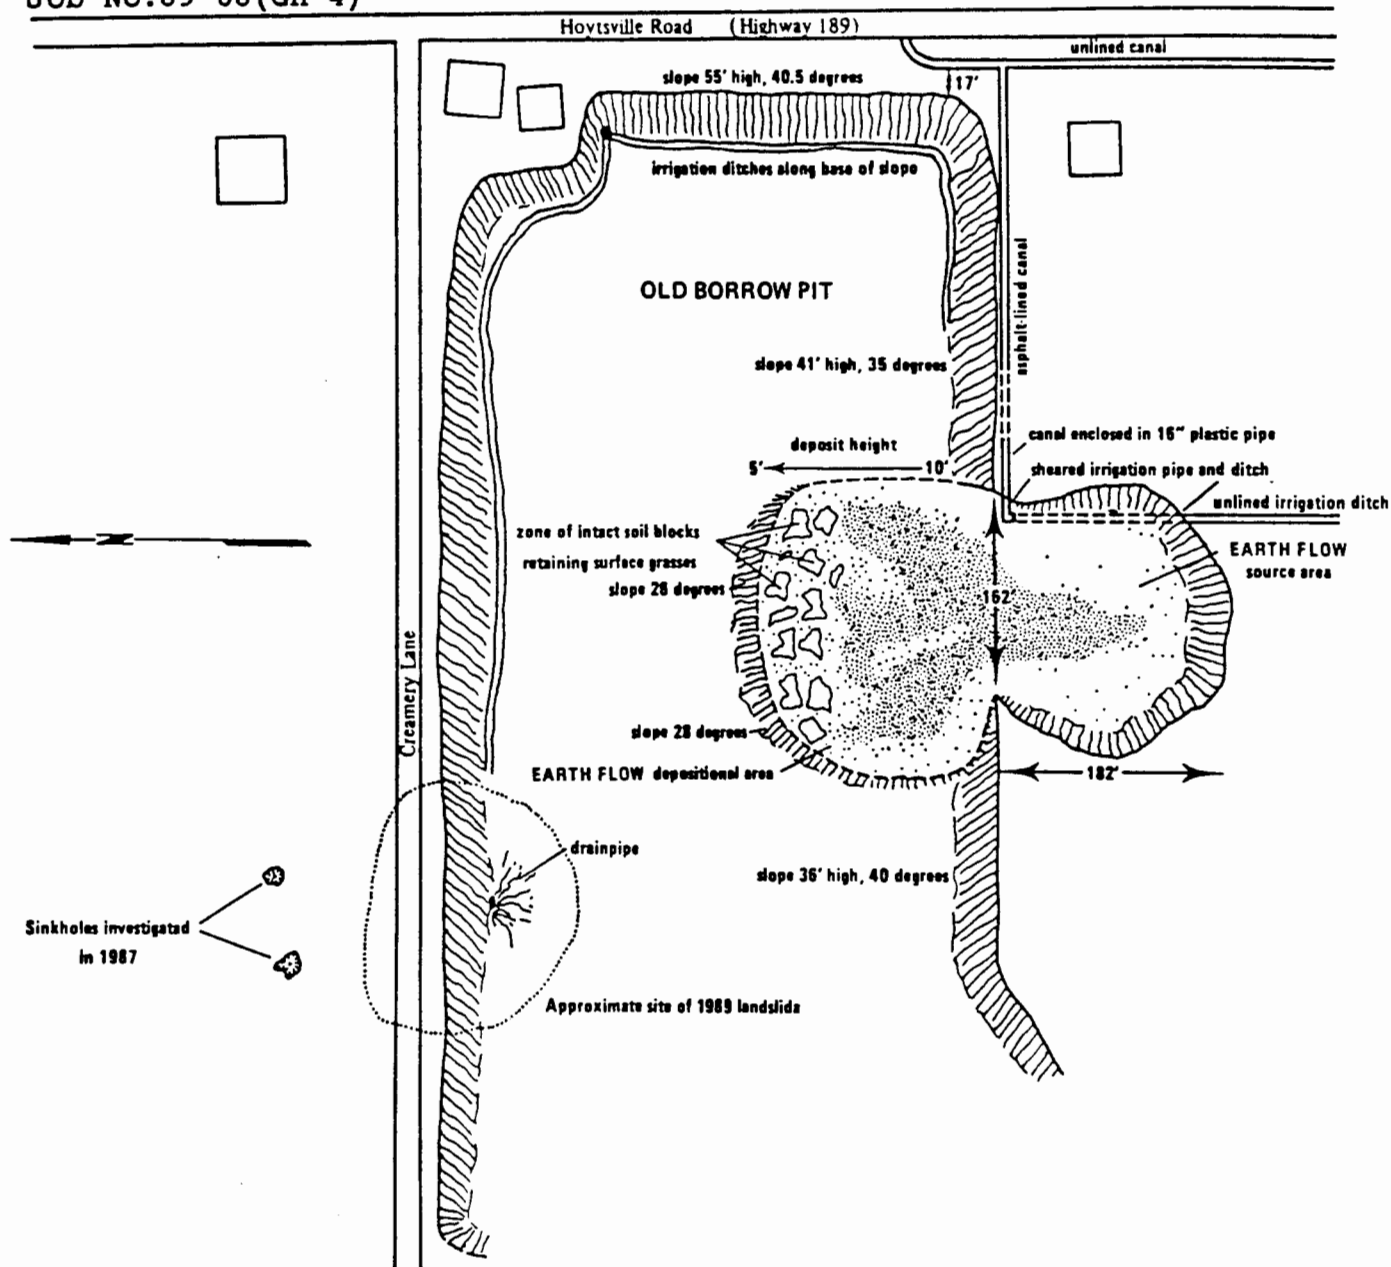
Figure 2. Sketch of landslide, borrow pit, and associated features (not drawn to scale).

The earth flow most likely occurred as a result of a combination of conditions. The main factors causing the failure are believed to be the steep slope, fine-grained soils, and excess moisture applied through flood irrigation and possible canal seepage. As depicted in figure 2, an asphalt-lined canal carried water west along the south edge of the borrow pit. Water was channeled into a 16-inch diameter plastic pipe which then angled southward to divert flow into an open, unlined irrigation ditch (fig. 2). The position of the irrigation ditch closely follows the eastern flank of the earth flow, and it is possible that seepage from the ditch, or elsewhere near the main scarp, may have triggered the earth flow. Due to the seven-month period between the earth flow and this investigation, moisture conditions at the time of failure are unknown. The only moisture observed during the field visit was a small amount of water trickling from the sheared-off pipe onto the earth flow below, and a few areas of ponded water at the bottom of the borrow pit near the toe of the earth flow.
